Appendix E: SCBA Report & Data Documentation

The National Personal Protective Technology Laboratory (NPPTL) has concluded its examination of a MSA Model G1, 4500 psi, 45-minute self-contained breathing apparatus (SCBA) under Task Number 22491.

Evaluation of a Self-Contained Breathing Apparatus Involved in a Fatality While Operating at a Structure Fire

Howard County Department of Fire and Rescue
Services Request for a MSA Model G1

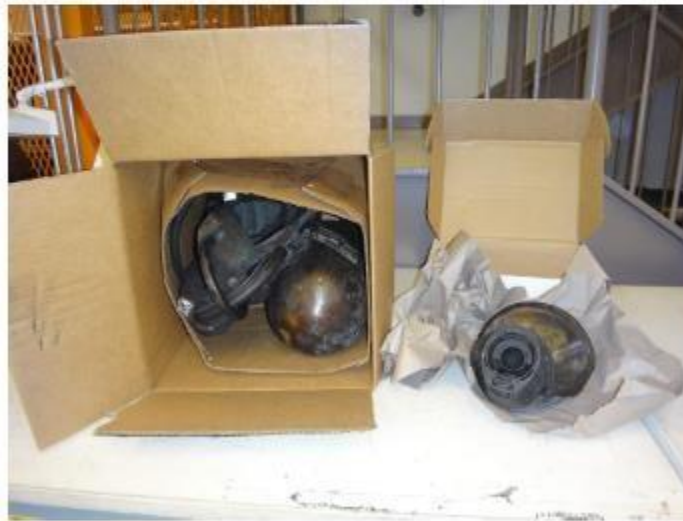
- SCBA unit was hand delivered to Lab H1513 by NIOSH DSR investigators
- Cylinder was received with 2250 psi and closed
- Bypass was closed
- Mask-mounted regulator (MMR) was securely connected to the low pressure line
- Facepiece was included

Figure 1: SCBA as received

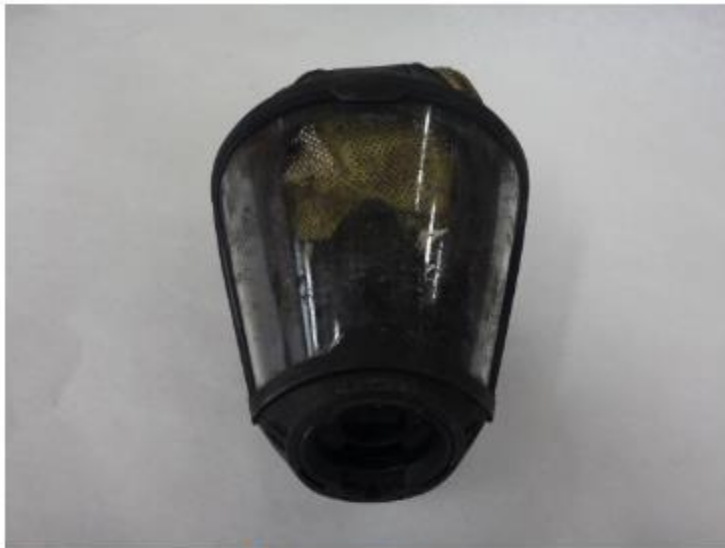
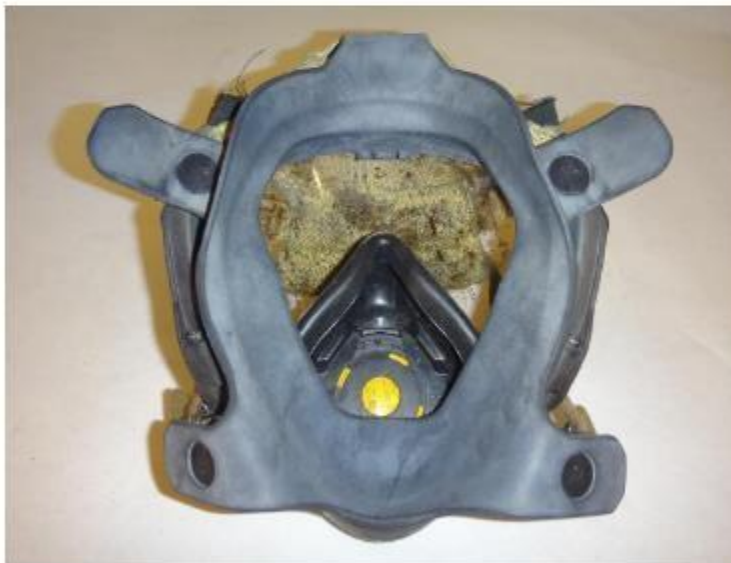
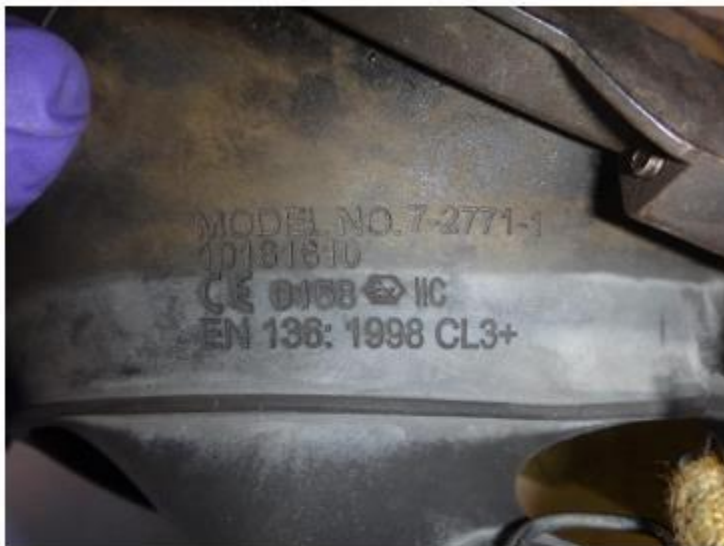
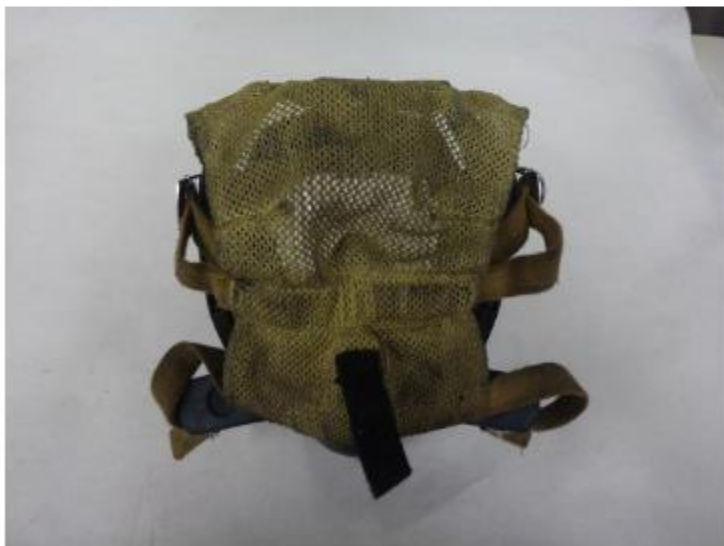
Facepiece (Figures 2-5)

- Facepiece seal P/N: 10161810; M/N: 7-2771-1; CE 0168 EXLLC; EN 136 1998 CL3+
- Nosecup MFG date: 8/14
- Overall condition: fair, dirty with scratches
- Lens was crazed and dirty
- Upper lens ring had molten debris on it
- Lens retaining ring was intact
- MMR housing was clean and in good condition
- HUD was present and intact
- Hairnet was in good condition with dirt present
- All straps and buckles functioned properly

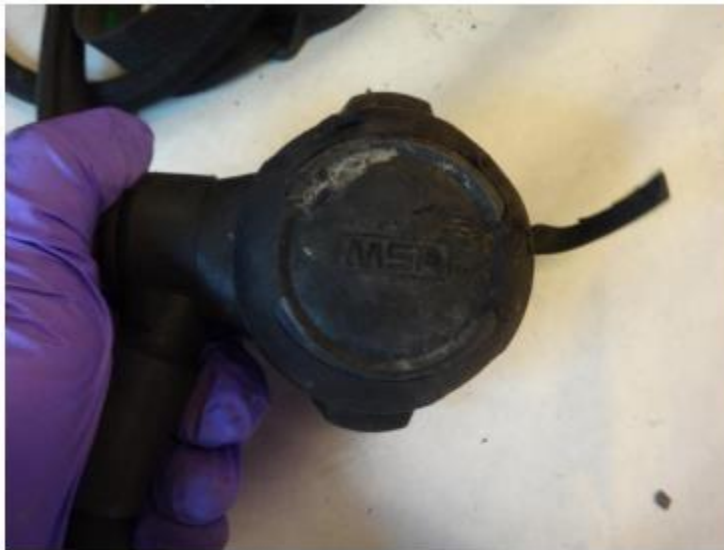
- MMR label on front: MSA; M/N: 7-2779-1
- Overall condition was dirty with signs of heat damage
- MMR was secured to low pressure line
- Bypass closed
- Inside flange had normal wear and in good condition
- Sealing area was fair and slightly dirty
- Regulator could be attached and removed
- Outer rubber casing had physical heat damage

Figure 6: Mask mounted regulator with signs of heat damage

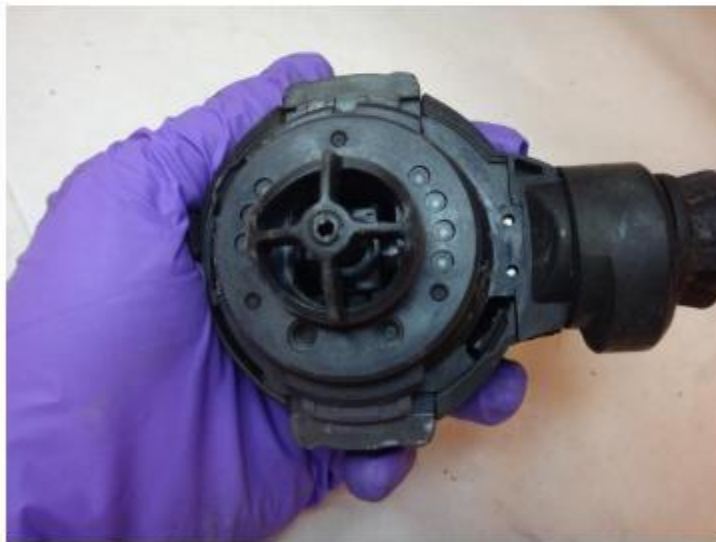
Figure 7: Inside of mask mounted regulator

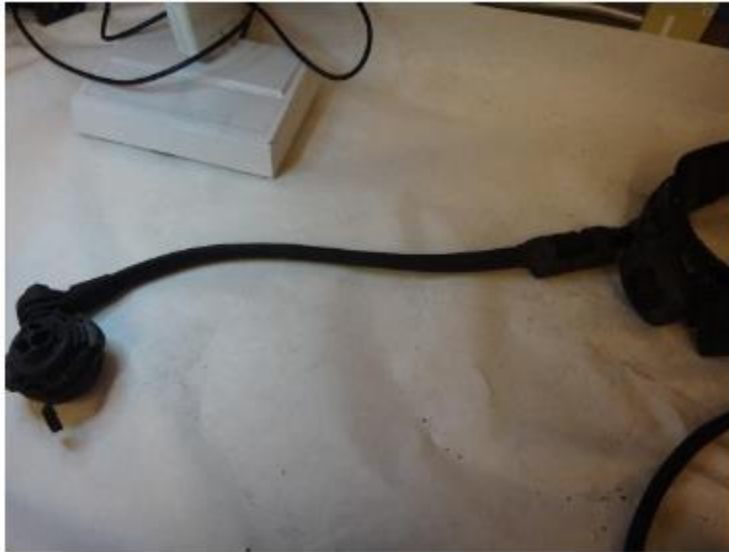
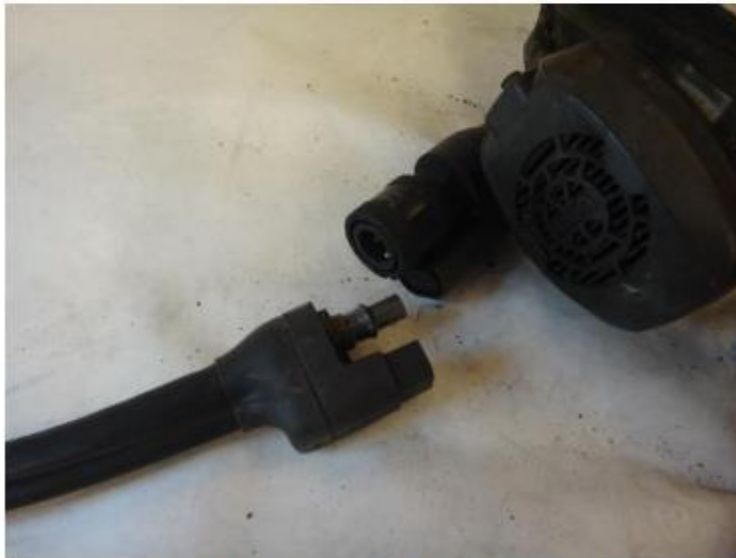
Low Pressure Regulator Hose (Figures 8-9)

- Secured at all attachment points
- Line was in good condition
- Line passed through the shoulder strap to the reducer

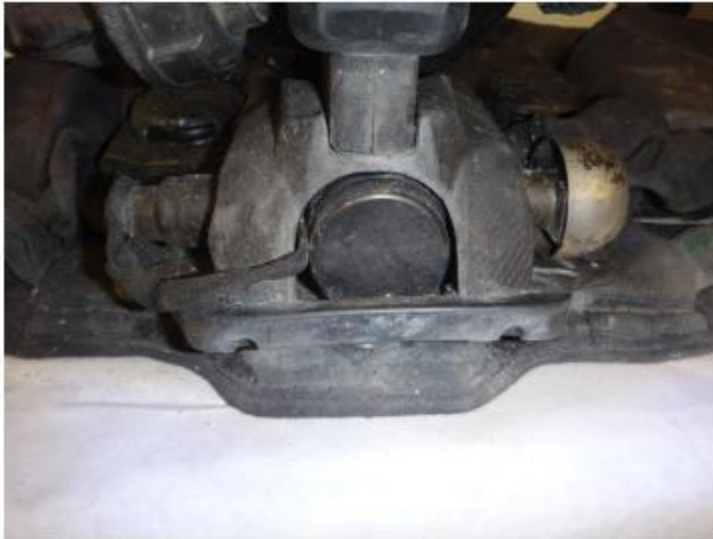
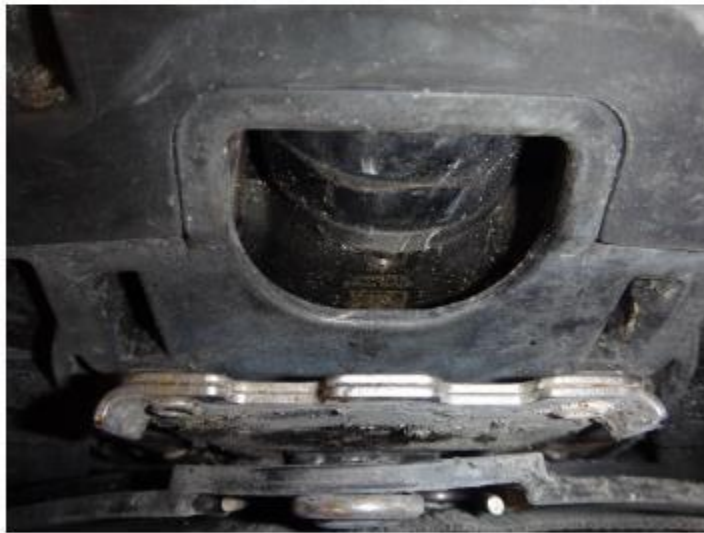
Pressure Reducer Assembly (Figure 10-11)

- Overall condition was good
- All airline connections were secure
- All lines going to the pressure reducer were in good condition
- 4500 Psi; 2115380

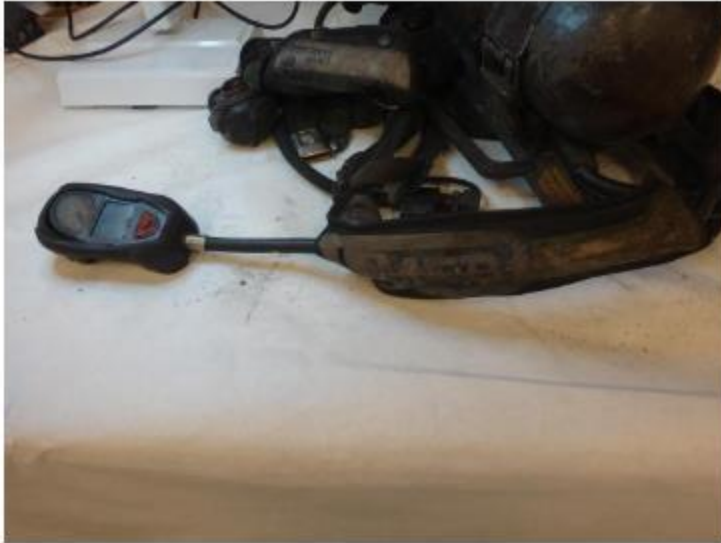
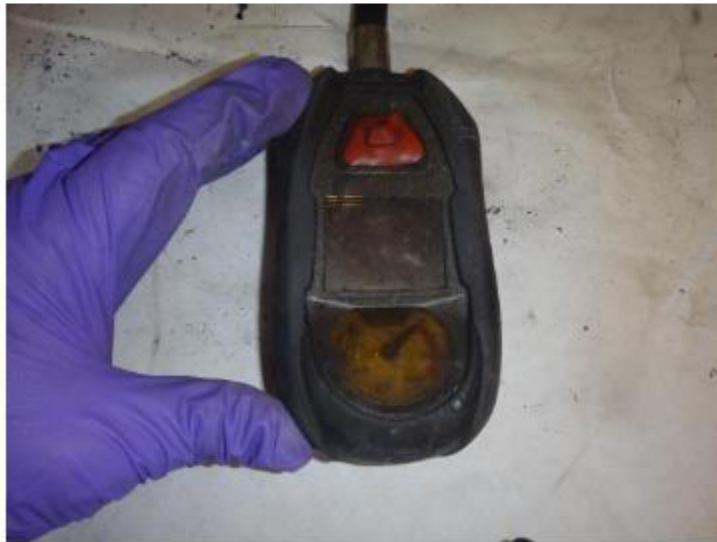
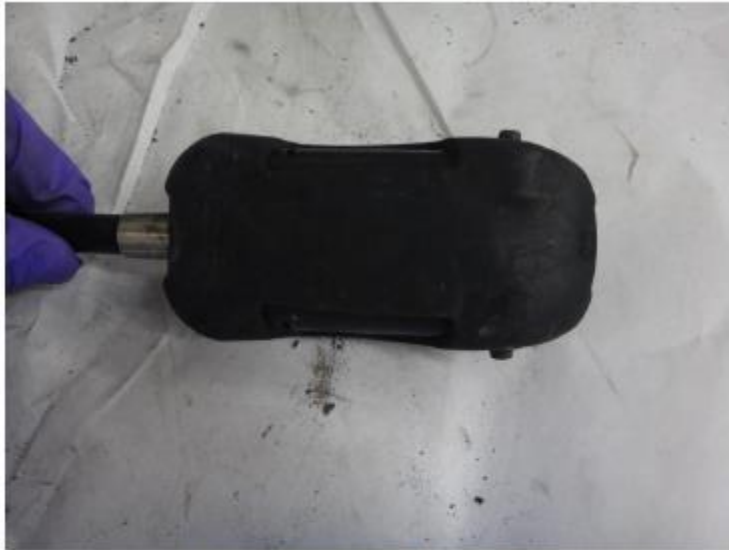
PASS Control Module (Figures 12-14)

- Lines to control module looked good
- Gauge lens was readable
- Protective casing was good and in place
- M/N 2816-1

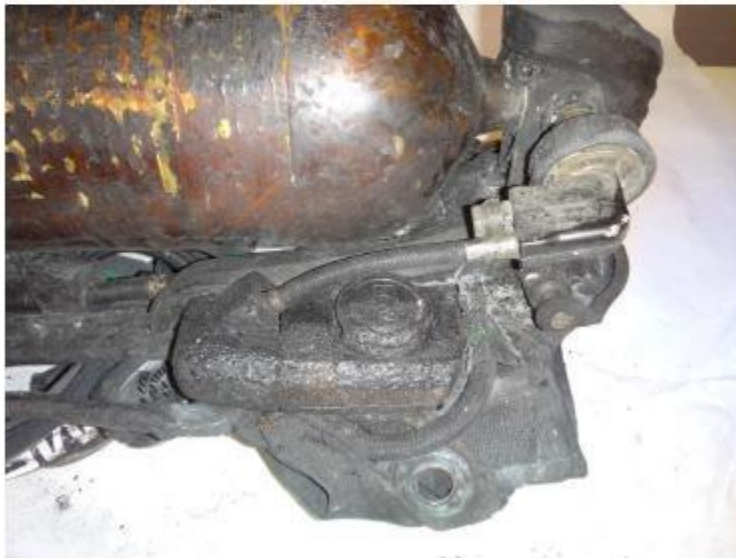
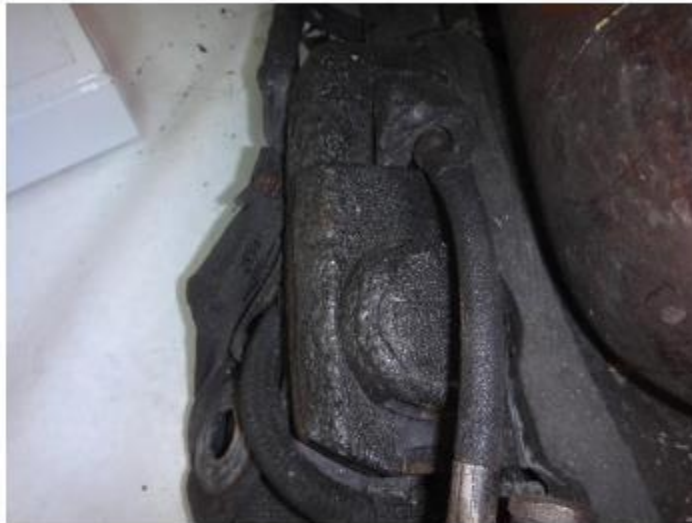
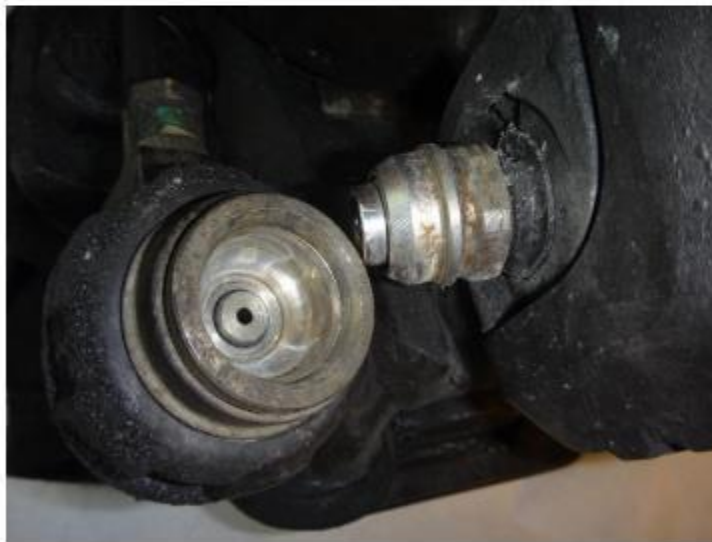
High Pressure Hose and Cylinder Attachment (Figures 15-17)

- High pressure S/N: 7-2844-1 DP
- High pressure line had heat damage, dirty
- Cylinder quick connect attachments were dirty; rubber wheel was burnt

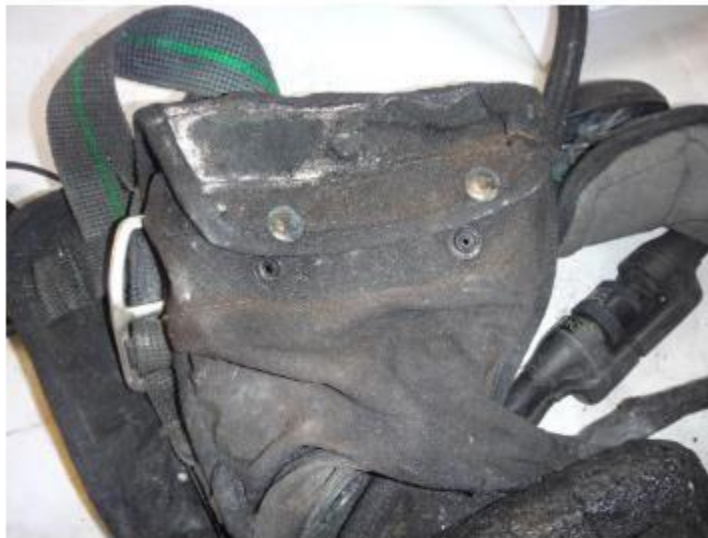
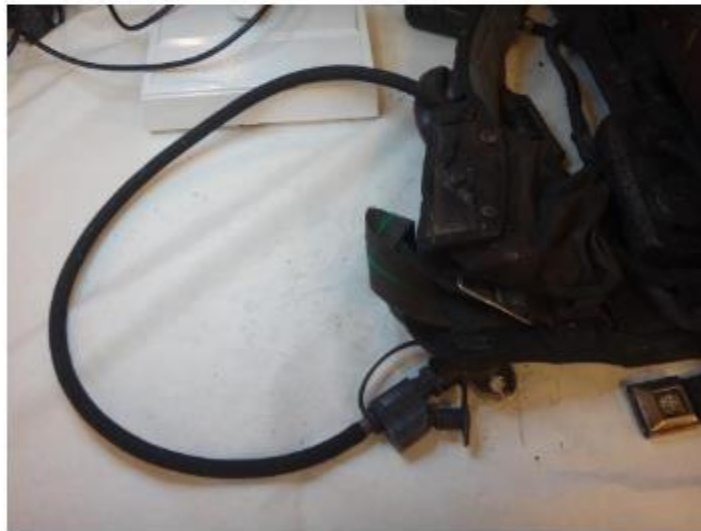
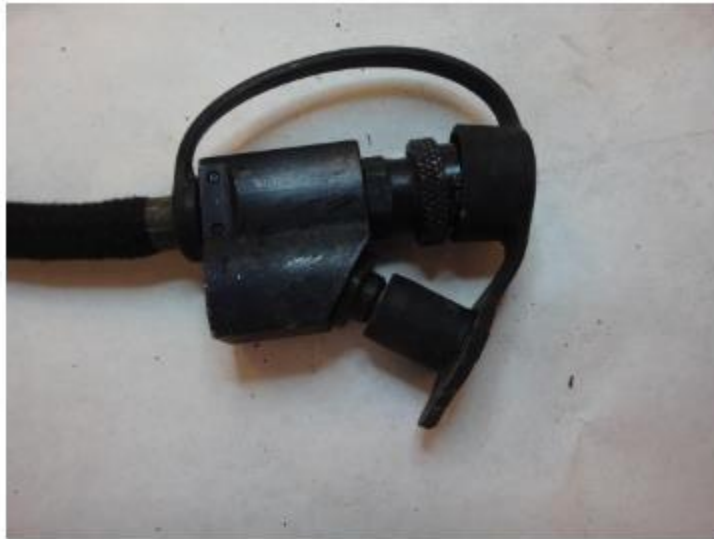
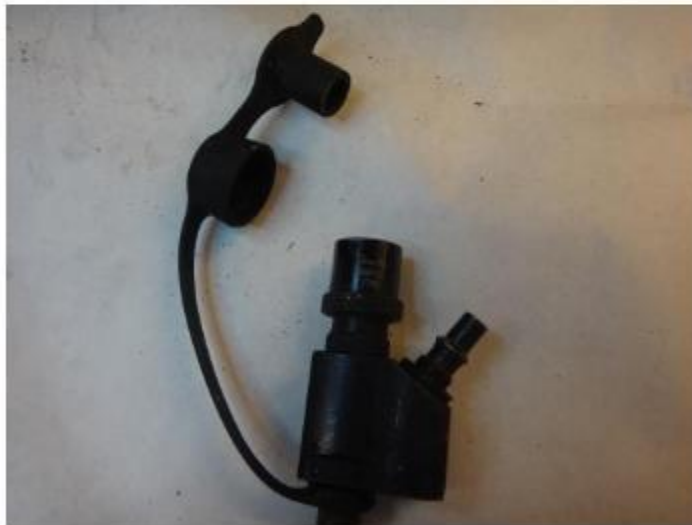
ExtendAir II EBSS (Emergency Breathing Support System (18-21)

- Quick Connect snap tite 9847-22; 3715
- Fair condition; covered with soot

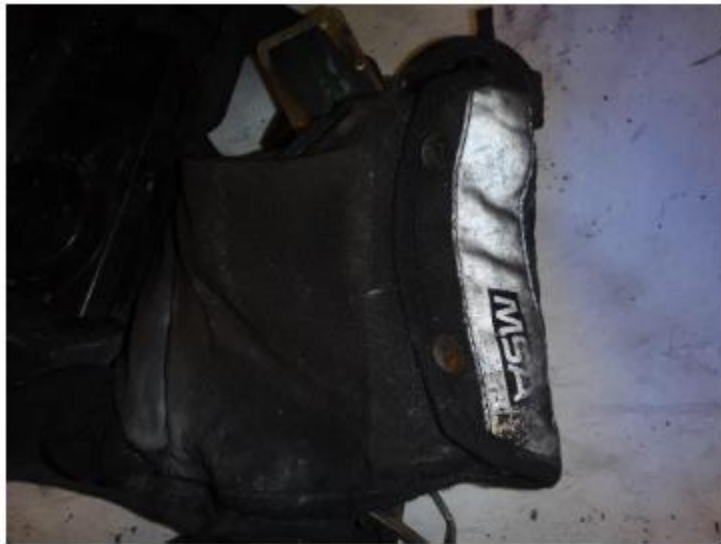
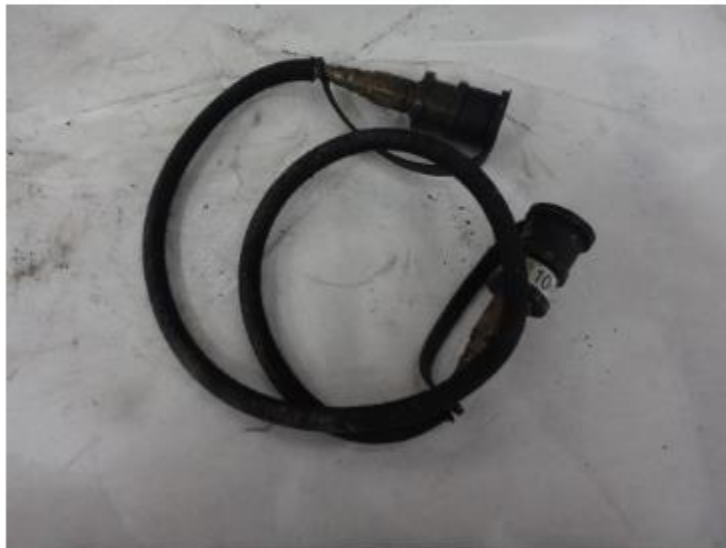
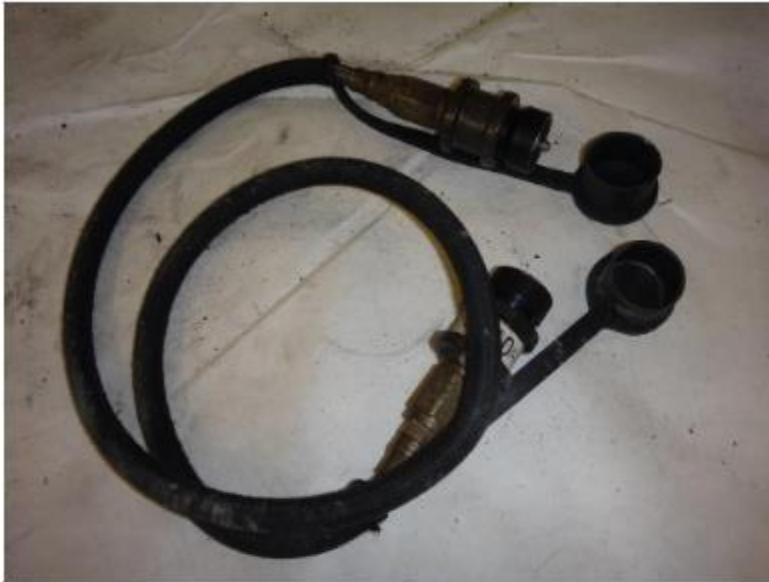
Quick-Fill line (22-24)

- FD 17 series
- HCFD; sticker 10-14
- Sleeve is frayed

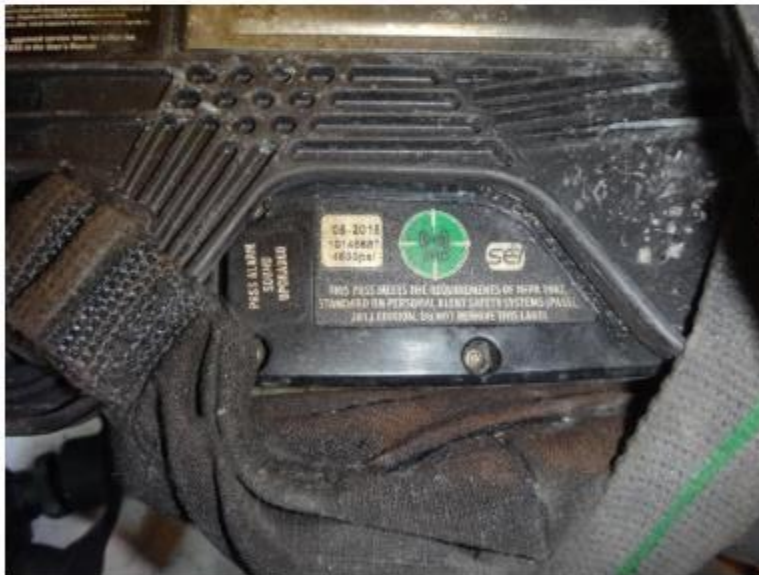
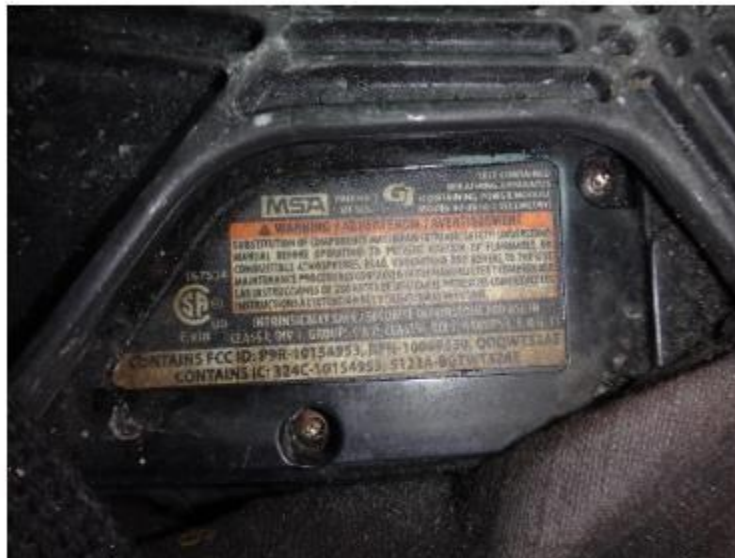
PASS Power Module (Figures 25-26)

- SEI label: 05-2015; 10148687 4500 psi; RFID
- PASS met requirements of NFPA 1982: Standard on Personal Alert Safety Systems (PASS) 2013 edition
- FCC ID P9R 10154953, RPN 10069330
- SCBA containing power module M/N 7-2810-1
- Overall condition was good, but very dirty with debris and melted in spots
- Held securely to backframe
- Power module battery was unattached, looked good with dirt

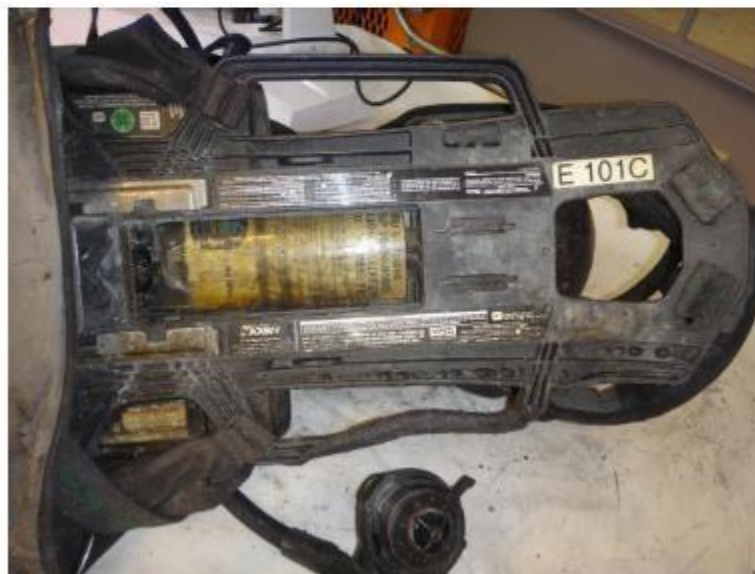
- S/N: 7-N/A
- SEI label 1981-2013 edition
- NIOSH Approval Number label: TC-13F-0798CBRN
- FD label with E 101C
- Overall condition was fair
- Extensive heat damage to left railing and right top
- Soot and debris were found everywhere
- Shoulder straps were attached to the frame

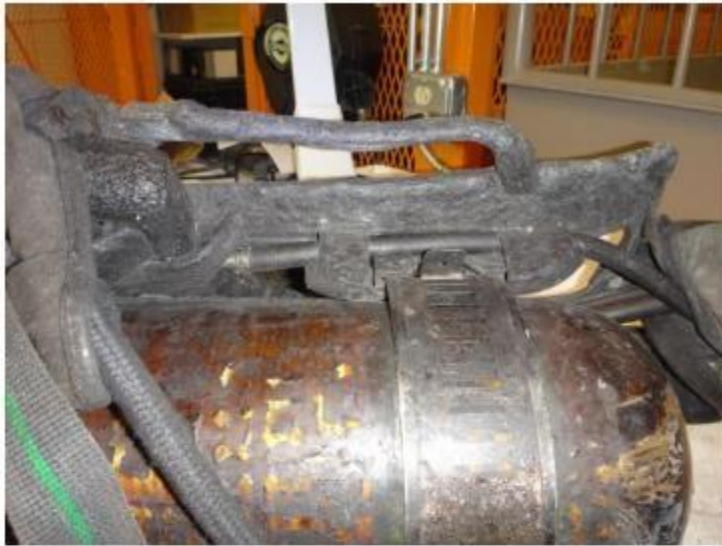
Figure 28: Cylinder strap and heat damage to side rail

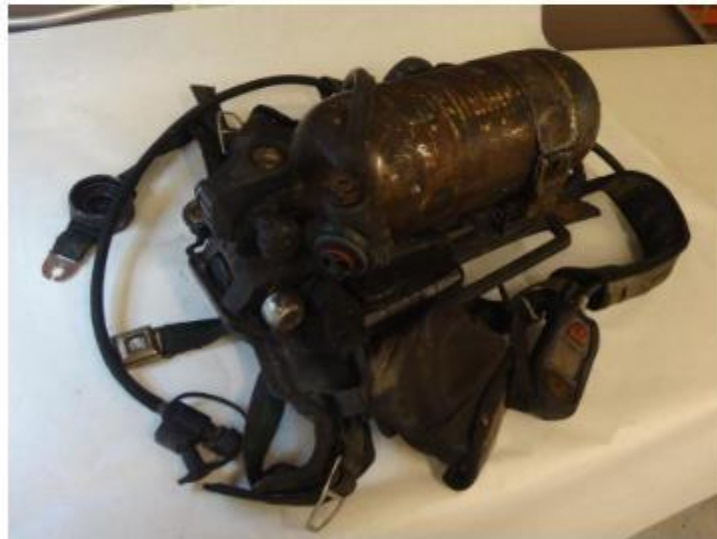
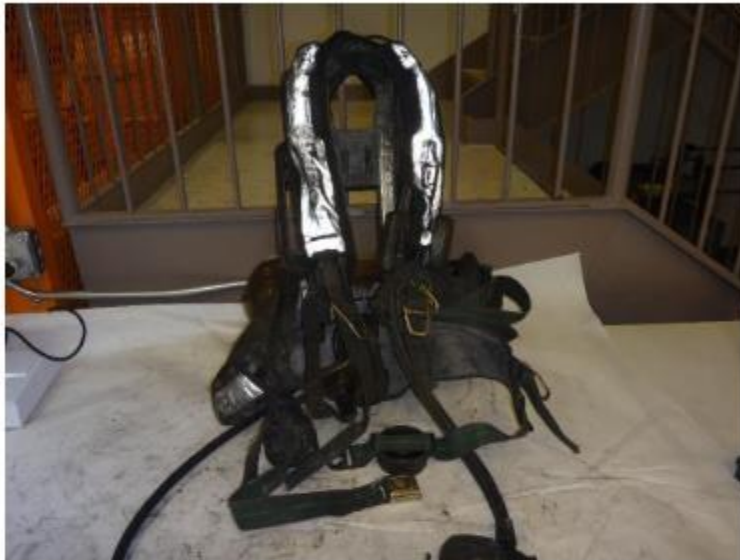
Straps and Buckles (Figures 29-30)

- Overall condition of straps was good, but dirty
- Hose lines passed through shoulder straps
- All adjustable buckles moved and held in place
- Waist area buckle latched

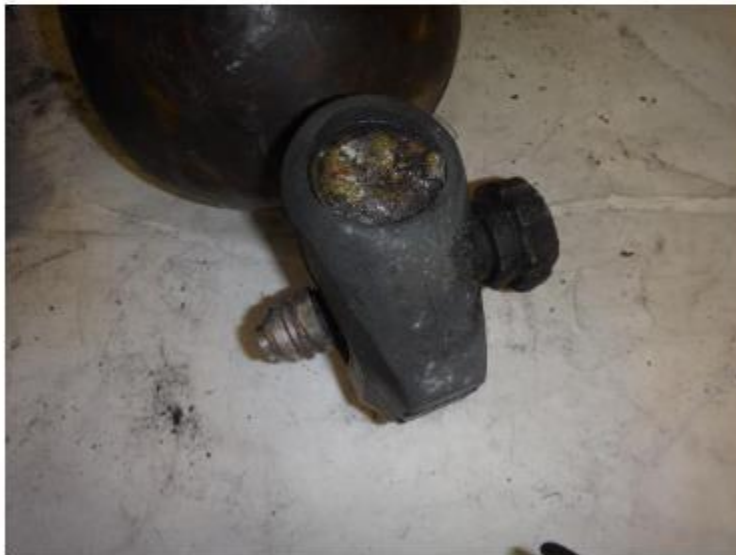
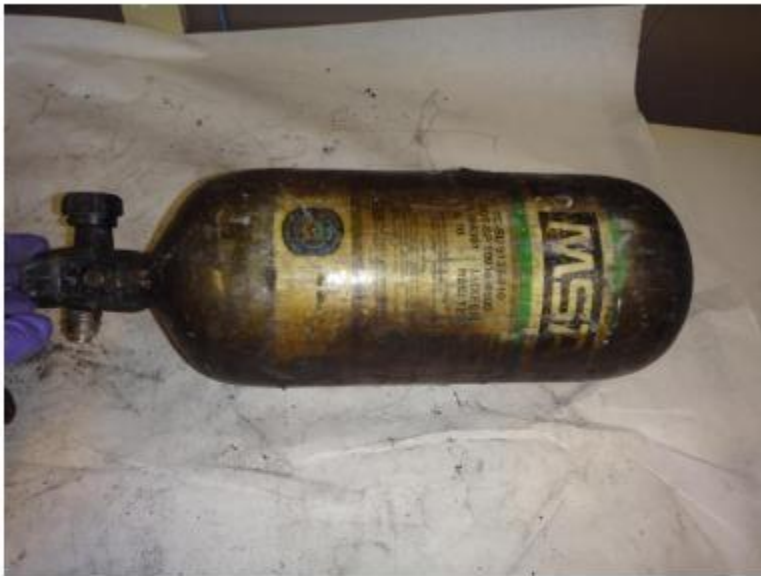
Compressed Air Cylinder and Cylinder Valve Assembly (Figures 31-32)

- DOT-SP 10915-4500; TC-SU-5134-310; OM 164301
- Luxfer P/N L65M-122; REE 123
- MSA M/N 7-1348-1
- Hydrostatic date: 7/2015; 45 minute, 4500 PSI
- Received with 2250 psi
- Overall condition was poor with heat damage
- Gauge was not readable
- Threads were good; attached to the threads was the male quick connect
- O-ring was present and in good condition
- Rubber bumper at base of cylinder valve was in good condition

**A replacement cylinder was used for testing due to damaged cylinder gauge on corresponding cylinder*
